## Mixmaster Rehabilitation NEWSLETTER

OCTOBER 2019

#### Project Status – What's Been Done So Far...

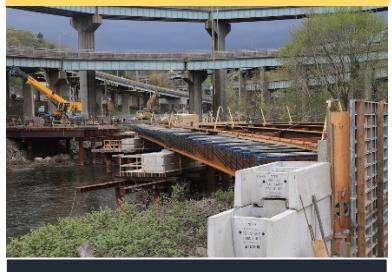
Temporary Bridge #2 – North View

This two-lane highway, less than one mile in length, consists of three temporary bridges: two over the Naugatuck River and one over Freight Street. Cranes were used to install the piles (steel beams) which support the abutments and piers of the new bridges. The piles were driven 60 to 70 feet into the ground and spaced 4 to 5 feet apart.

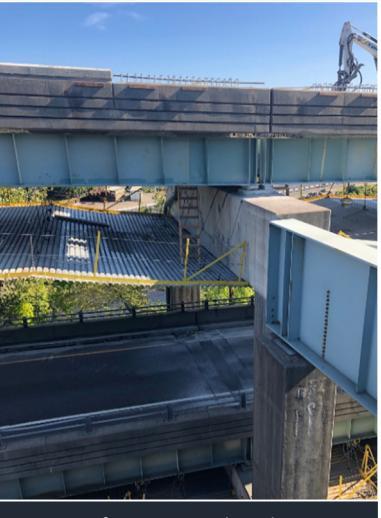
Safespan Beneath Bridge

Platforms were set up above and below the highways and bridges. These work platforms are used to provide access to complete the concrete and steel repair work. The platform also serves to provide protection of any falling debris. Since the bridges were built back in 1960's, it is imperative to rehabilitate them for the safety of the traveling public.

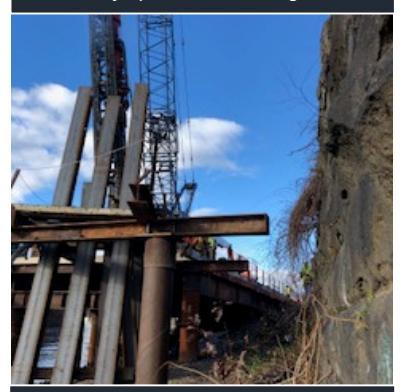
Temporary Bypass - Construction
